EXISTING AGRICULTURAL DRAIN TILE INVESTIGATION PLAN

WILSON SCHOOL SOLAR

Prepared for: SUNVEST SOLAR, LLC

EXISTING SUBSURFACE AGRICULTURAL DRAIN TILE INVESTIGATION REPORT

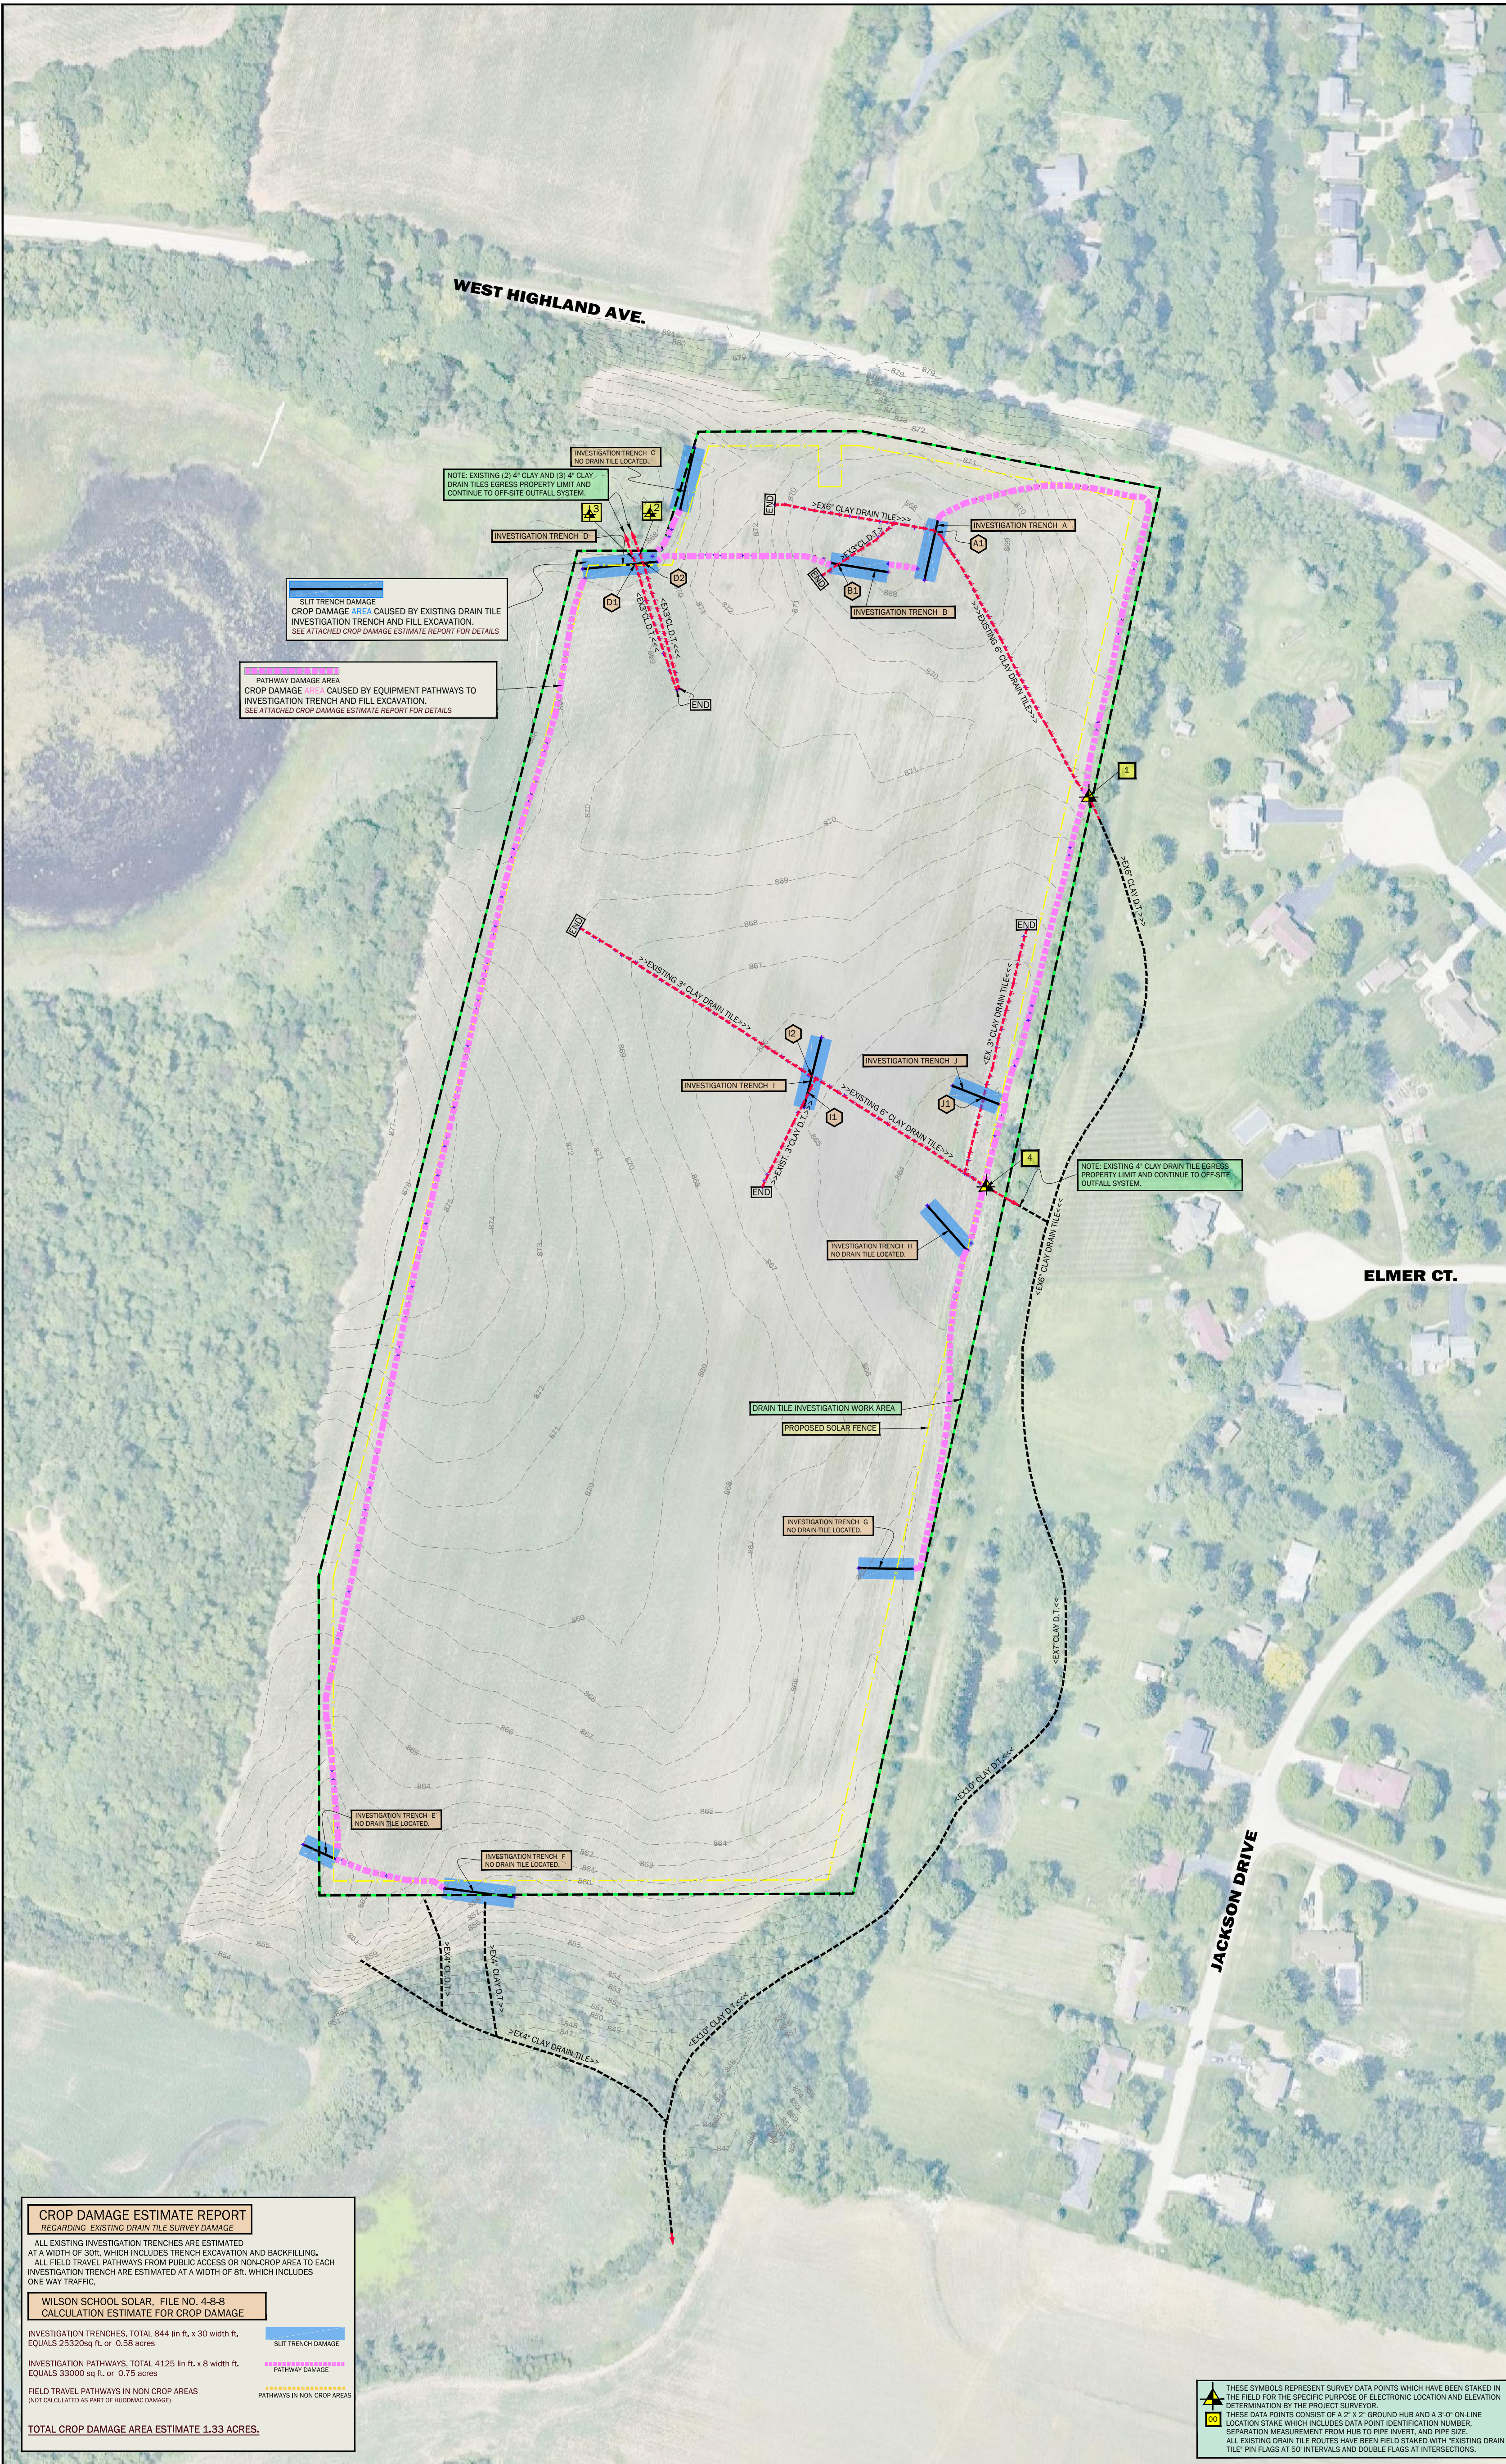
ID NO.	SZ.	TYPE / QUALITY	FLOW %	SILT %	DEPTH (IN.)	FIELD NOTES:
A1	6"	CLAY / GOOD	SLIGHT	10%	37"	ACTIVE FLOW RATE AND CAPACITY
B1	3"	CLAY / GOOD	SLIGHT	10%	39"	ACTIVE FLOW RATE AND CAPACITY
C	—	NO DRAIN TILES	—	—	—	NO DRAIN TILE LOCATED
D1	3"	CLAY / GOOD	SLIGHT	20%	33"	ACTIVE FLOW RATE AND CAPACITY
D2	3"	CLAY / GOOD	SLIGHT	90%	22"	SILT RESTRICTED / PARTIAL CAPACITY
E	—	NO DRAIN TILES	—	—	—	NO DRAIN TILE LOCATED
F	—	NO DRAIN TILES	—	—	—	NO DRAIN TILE LOCATED
G	—	NO DRAIN TILES	—	—	—	NO DRAIN TILE LOCATED
H	—	NO DRAIN TILES	—	—	—	NO DRAIN TILE LOCATED
I	3"	CLAY / GOOD	SLIGHT	10%	24"	ACTIVE FLOW RATE AND CAPACITY
I2	4"	CLAY / GOOD	SLIGHT	38%	38"	ACTIVE FLOW RATE AND CAPACITY
J1	3"	CLAY / GOOD	SLIGHT	15%	33"	ACTIVE FLOW RATE AND CAPACITY

DATA POINT	SZ.	TYPE / QUALITY	FLOW %	SILT %	DEPTH (IN.)	FIELD NOTES:
1	6"	CLAY / GOOD	SLIGHT	10%	60"	MAINLINE AT PROPERTY EGRESS
2	3"	CLAY / GOOD	SLIGHT	90%	26"	LATERAL AT PROPERTY EGRESS
3	3"	CLAY / GOOD	SLIGHT	10%	34"	LATERAL AT PROPERTY EGRESS
4	4"	CLAY / GOOD	SLIGHT	CLEAN	28"	MAINLINE AT PROPERTY EGRESS

- All existing agricultural drain tiles located during this investigation survey have been identified on this plan and field staked at 50' intervals, in some occasions certain existing local drain tile sections may be speculated and considered as an assumed route which shall be delineated on this plan.

- This drain tile investigation report is intended to identify existing drain tile mainline systems only with additional priority on drain tiles which may service the upland property of others or with mutual drainage status.

- Solar Field Development - It is our recommendation that all existing drain tile systems within the proposed solar field development should be replaced by "like kind" construction which will assure the location and replacement of unknown drain tile systems that were not located by this Existing Drain Tile Investigation.
