Area M Consulting (Area M), on behalf of SV CSG Wilson School Solar, LLC conducted a field wetland delineation within the proposed SV CSG Wilson School Solar, LLC (Project) located near Elgin in Kane County.

**Wetland Delineation Report**  
***SV CSG Wilson School Solar, LLC***  
*Kane County, Illinois*

## Map 3. Wetland Map

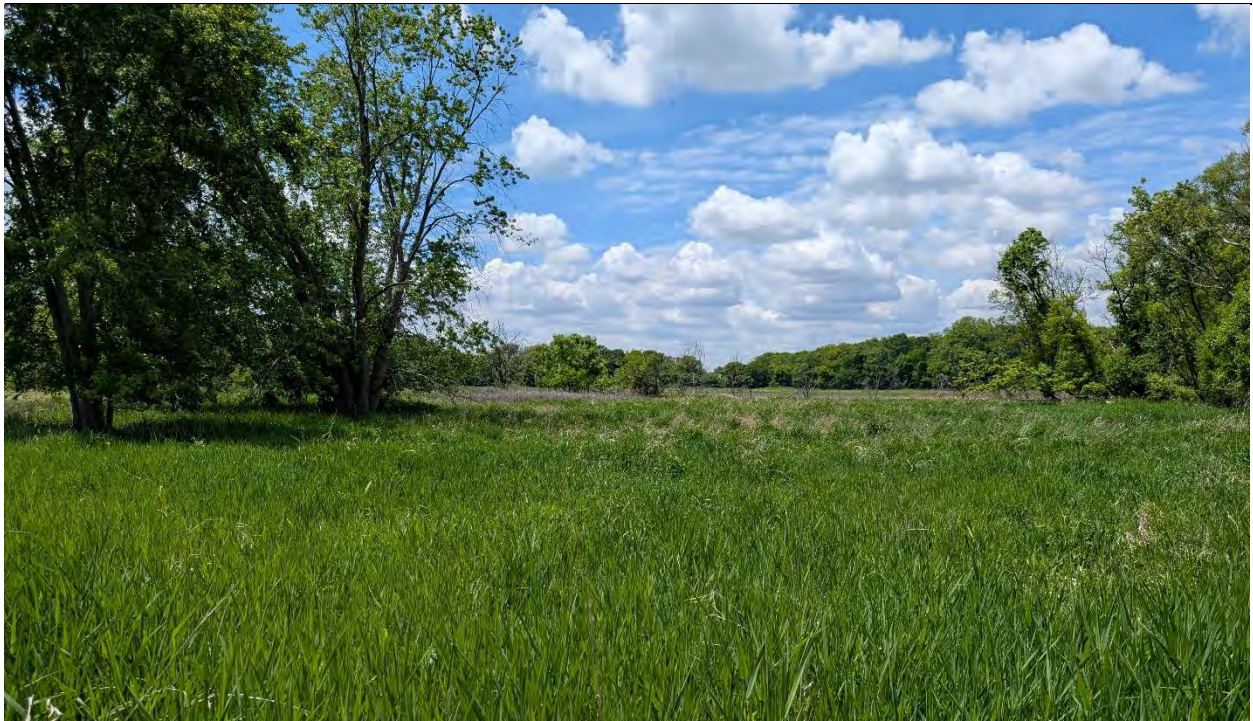
Wetland 1, viewed to the west from the eastern portion of the feature

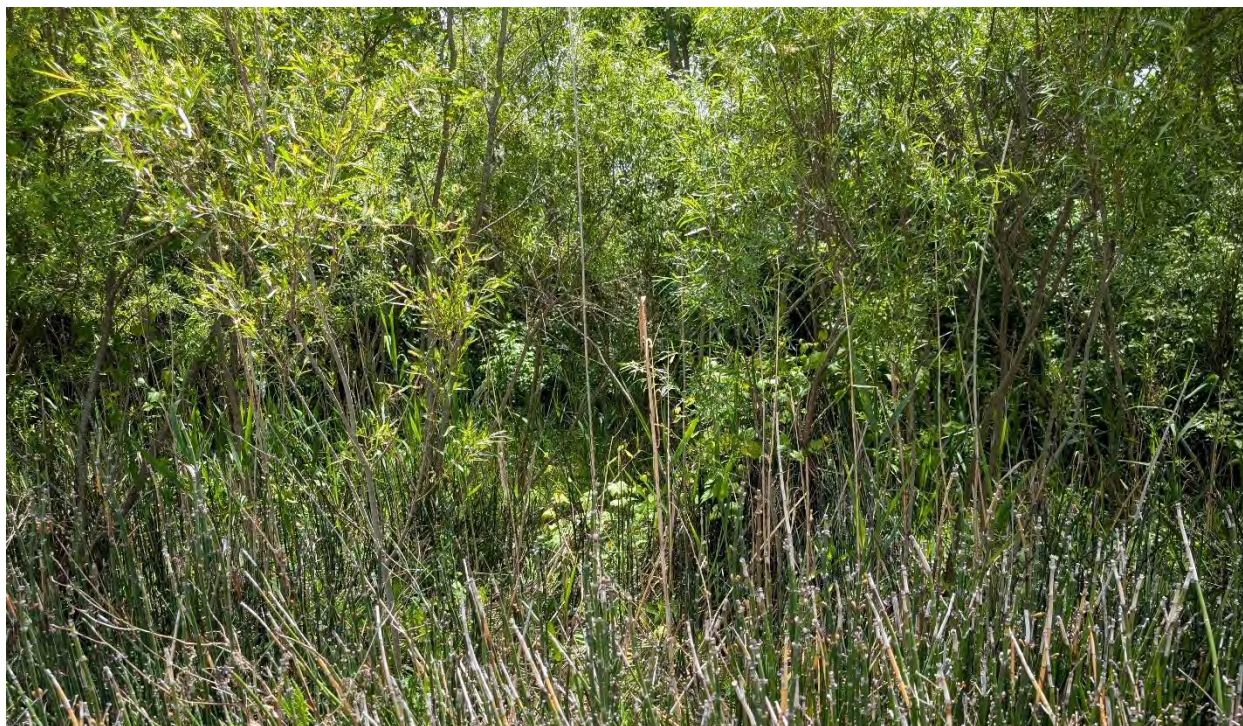
Wetland 2, viewed to the south from the edge of the feature

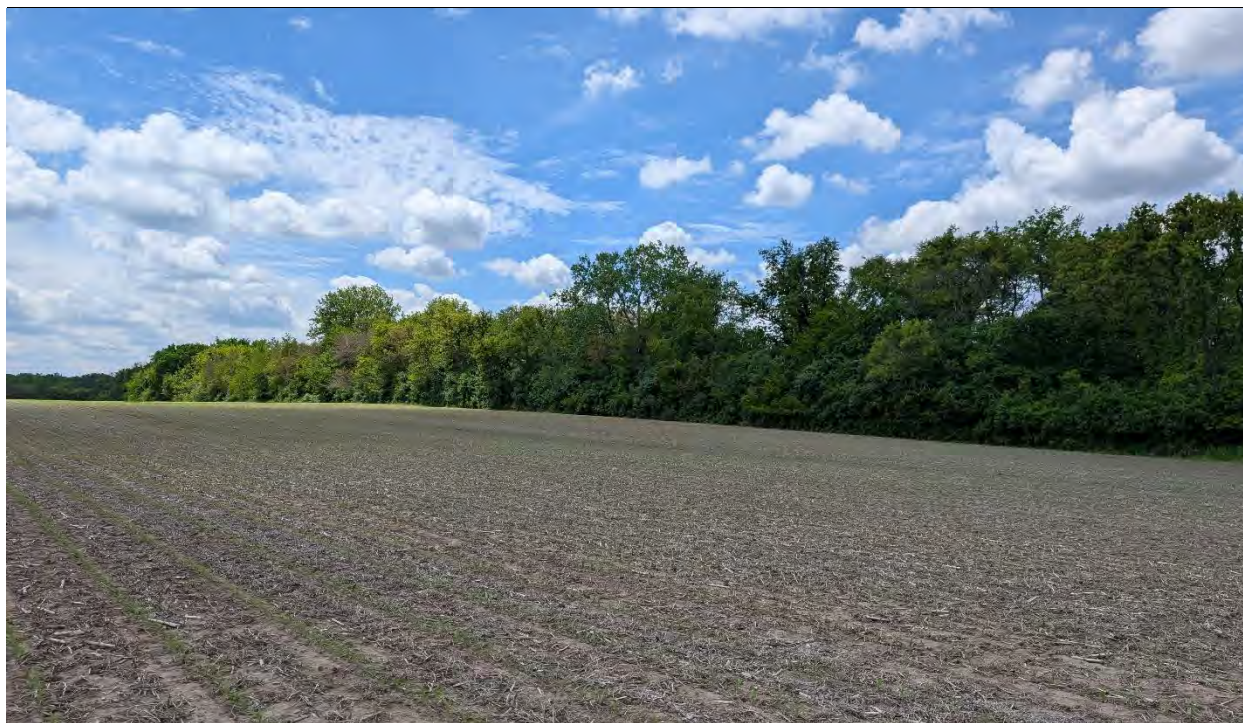
Area 2, identified during off-site review, is a small depression adjacent to the off-site pond in the northwestern portion of the Study Area. This Area showed wetland hydrology signatures in 4 of 14 slides with normal antecedent precipitation, indicating this Area is upland. Furthermore, it appears tiling was function before 2009 and after 2021. The tenant farmer indicated broken tiles were recently fixed throughout the site. At SP 2, wetland hydrology indicators were absent, and Area 2 was determined upland.

Area 2, viewed to the southwest from the beyond the eastern extent of the feature

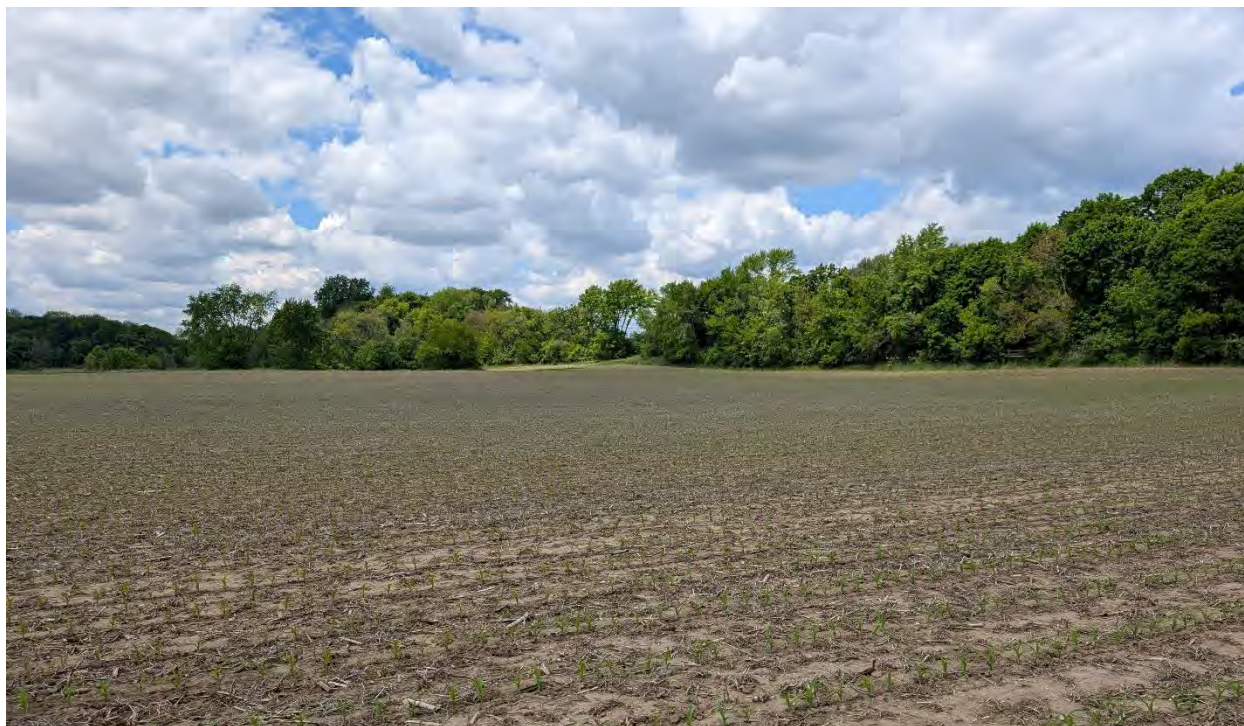
Area 3, identified during off-site review, is a small, closed depression in the northcentral portion of the Study Area. 8 of 14 slides with normal antecedent precipitation conditions, indicating this is a wetland. However, recent photos coupled with the site investigation suggest Area 3 has had drain tiles fixed or installed, and the area may have been filled. Aerial imagery suggests this occurred in 2021. Imagery prior to 2009 suggests drain tiles were functioning. The tenant farmer indicated broken tiles were recently fixed throughout the site. At SP 3, wetland hydrology indicators were absent, and Area 4 was determined to be currently upland.

Area 3, viewed to the northwest from the edge of the feature

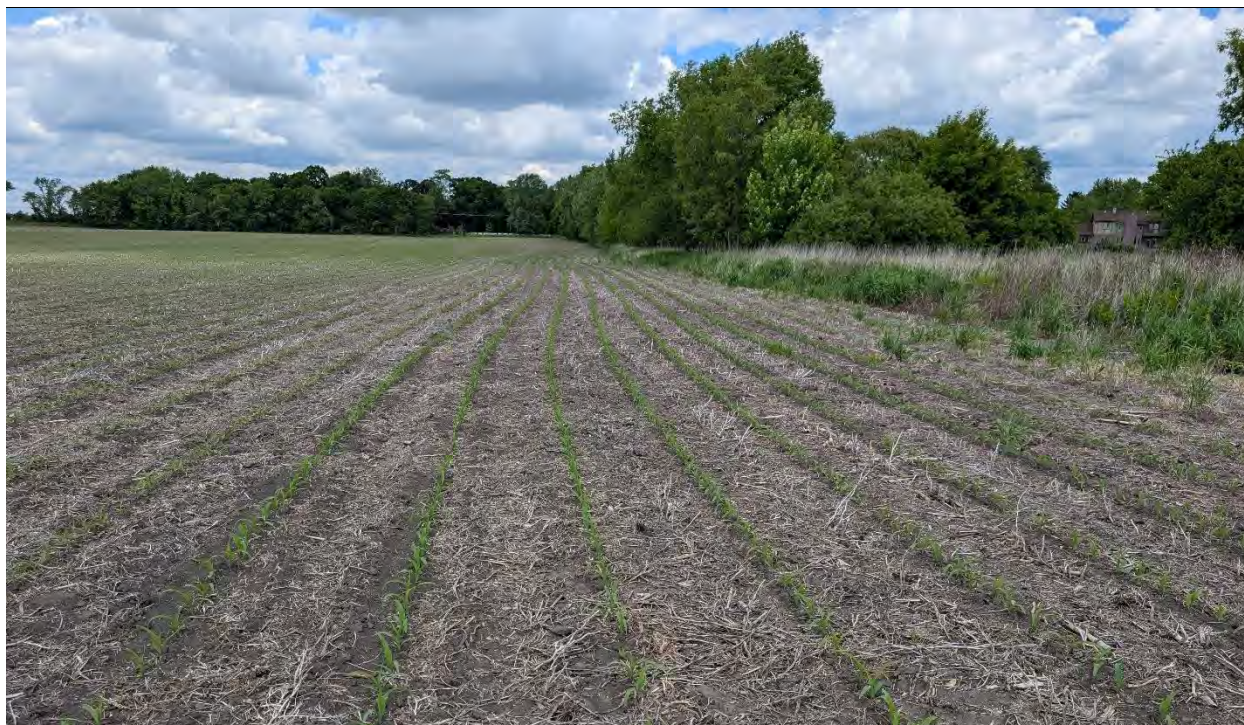
Area 4, identified during off-site review, is a small depression adjacent to the off-site pond in the northwestern portion of the Study Area. This Area showed wetland hydrology signatures in 9 of 14 slides with normal antecedent precipitation, indicating this Area is a wetland. However, recent photos coupled with the site investigation suggest Area 4 has had drain tiles fixed or installed. Aerial imagery suggests this occurred in 2021. Imagery prior to 2009 suggests drain tiles were functioning. The tenant farmer indicated broken tiles were recently fixed throughout the site. At SP 3, wetland hydrology indicators were absent. Furthermore, the soils were very distinct, light, and had a gravel and sand component. Area 3 was determined to be currently upland.

Area 4, viewed to the north from the southern edge of the feature
