## **APPENDIX D – WETLAND DELINEATION REPORT**

## MEMORANDUM

Subject: *Blackberry Township, Kane County, Illinois – KN216 Level 1 Wetland Delineation Memorandum*

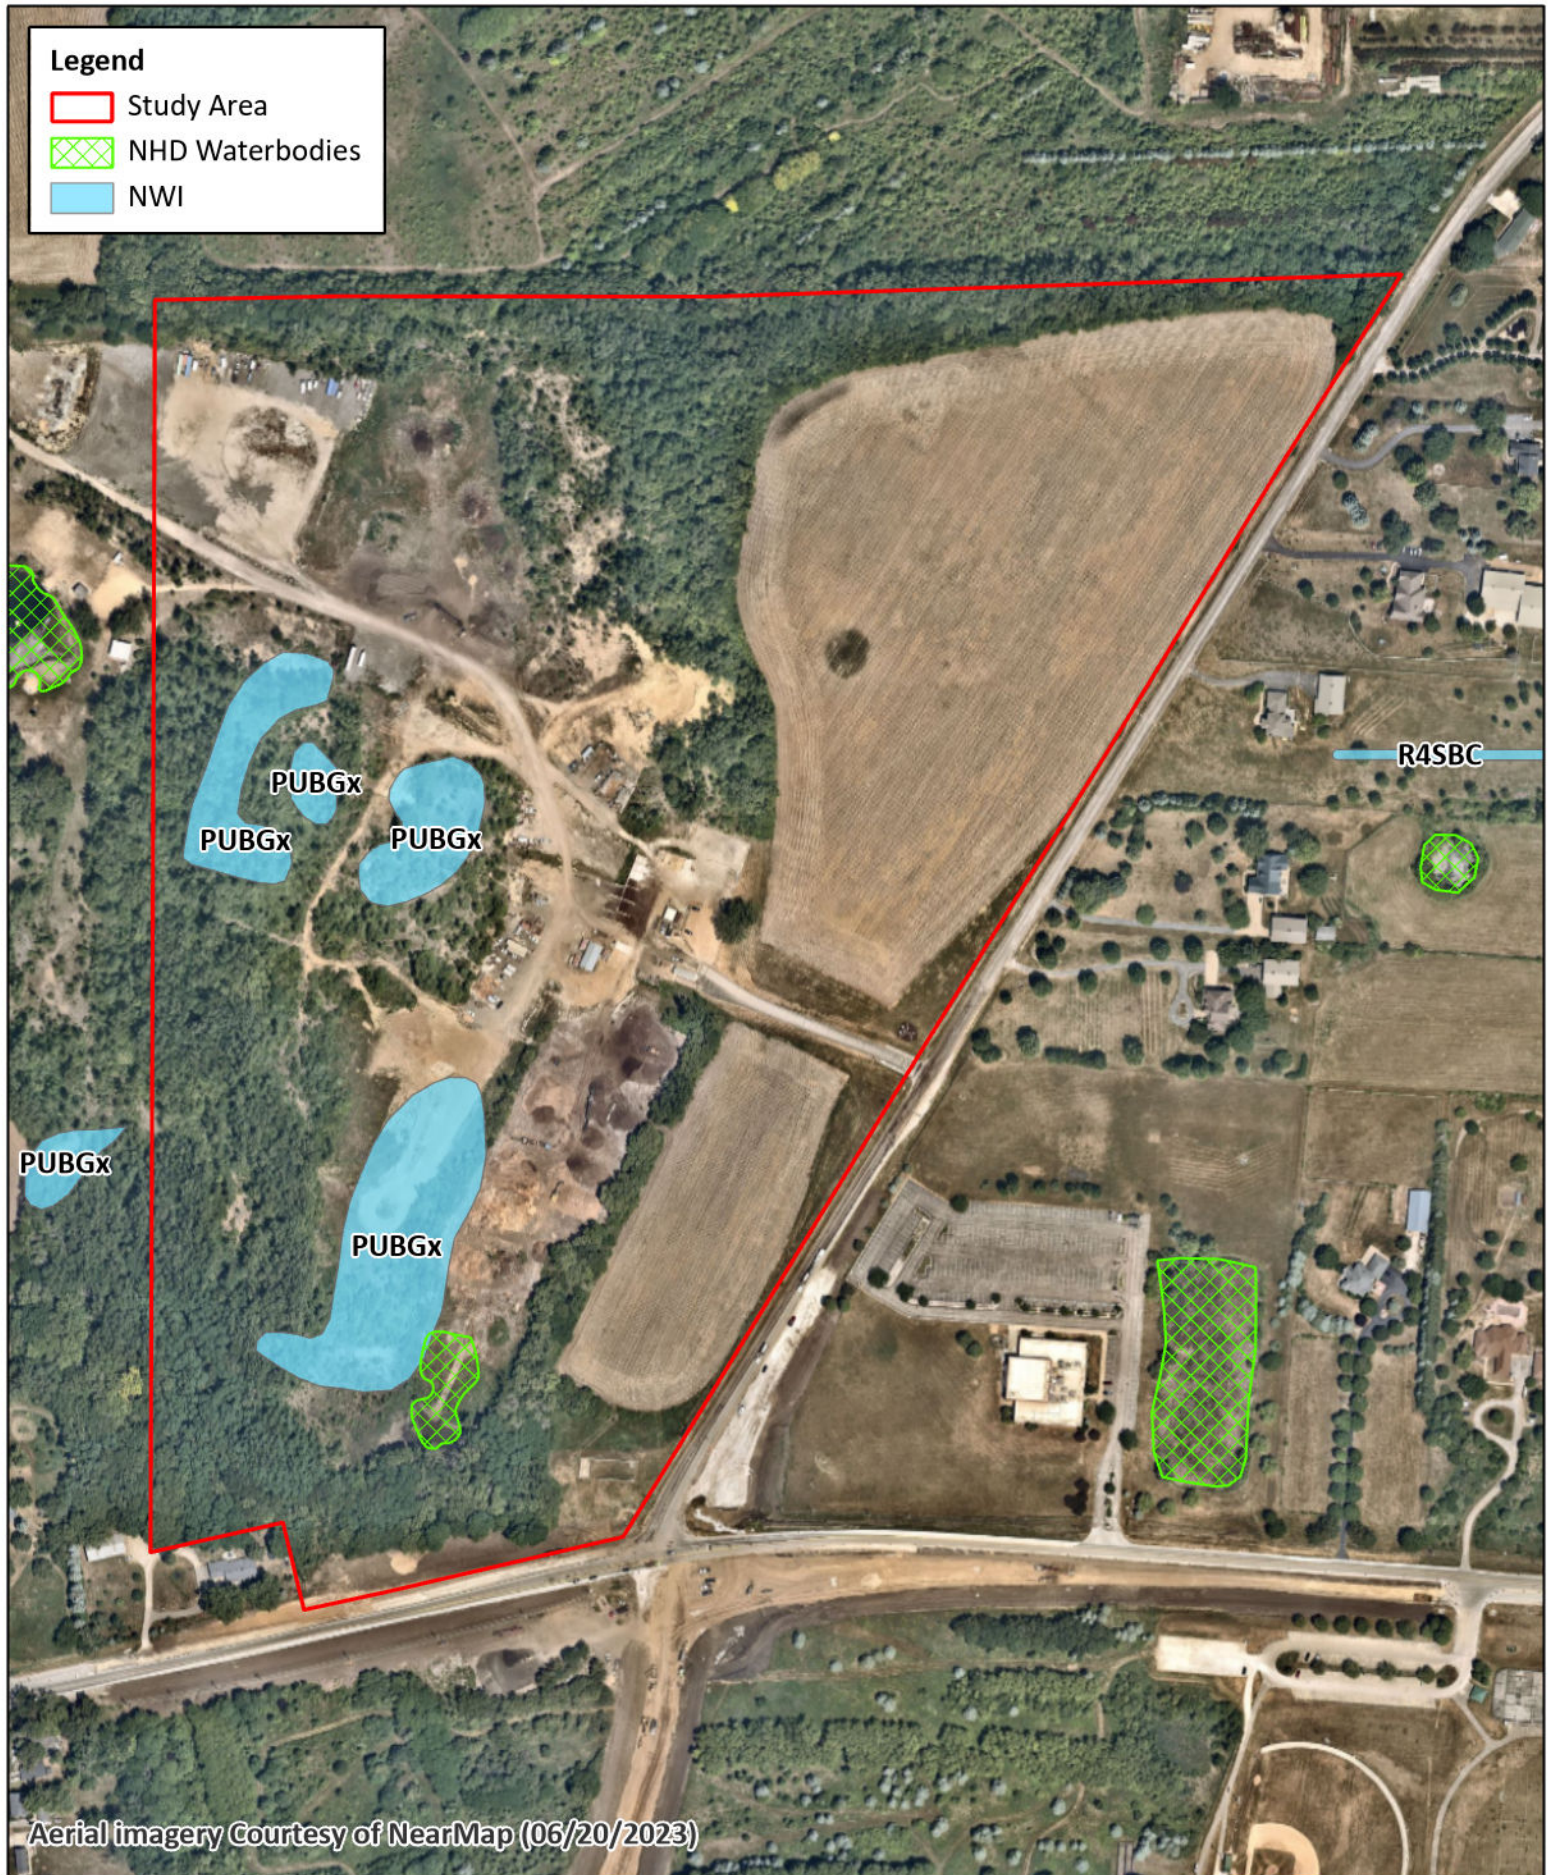
A review of the Sugar Grove, Illinois 7.5-minute topographical quadrangle depicts gravel pits on the eastern end of the study area. There is an unimproved road that crosses from the northwestern corner of the study to the middle of the eastern border. An intermittent pond is located on the southern portion of the study area. A building is identified in the southeastern corner of the study area. The study area is primarily undeveloped land. The USGS topographical map is presented as Figure 3.

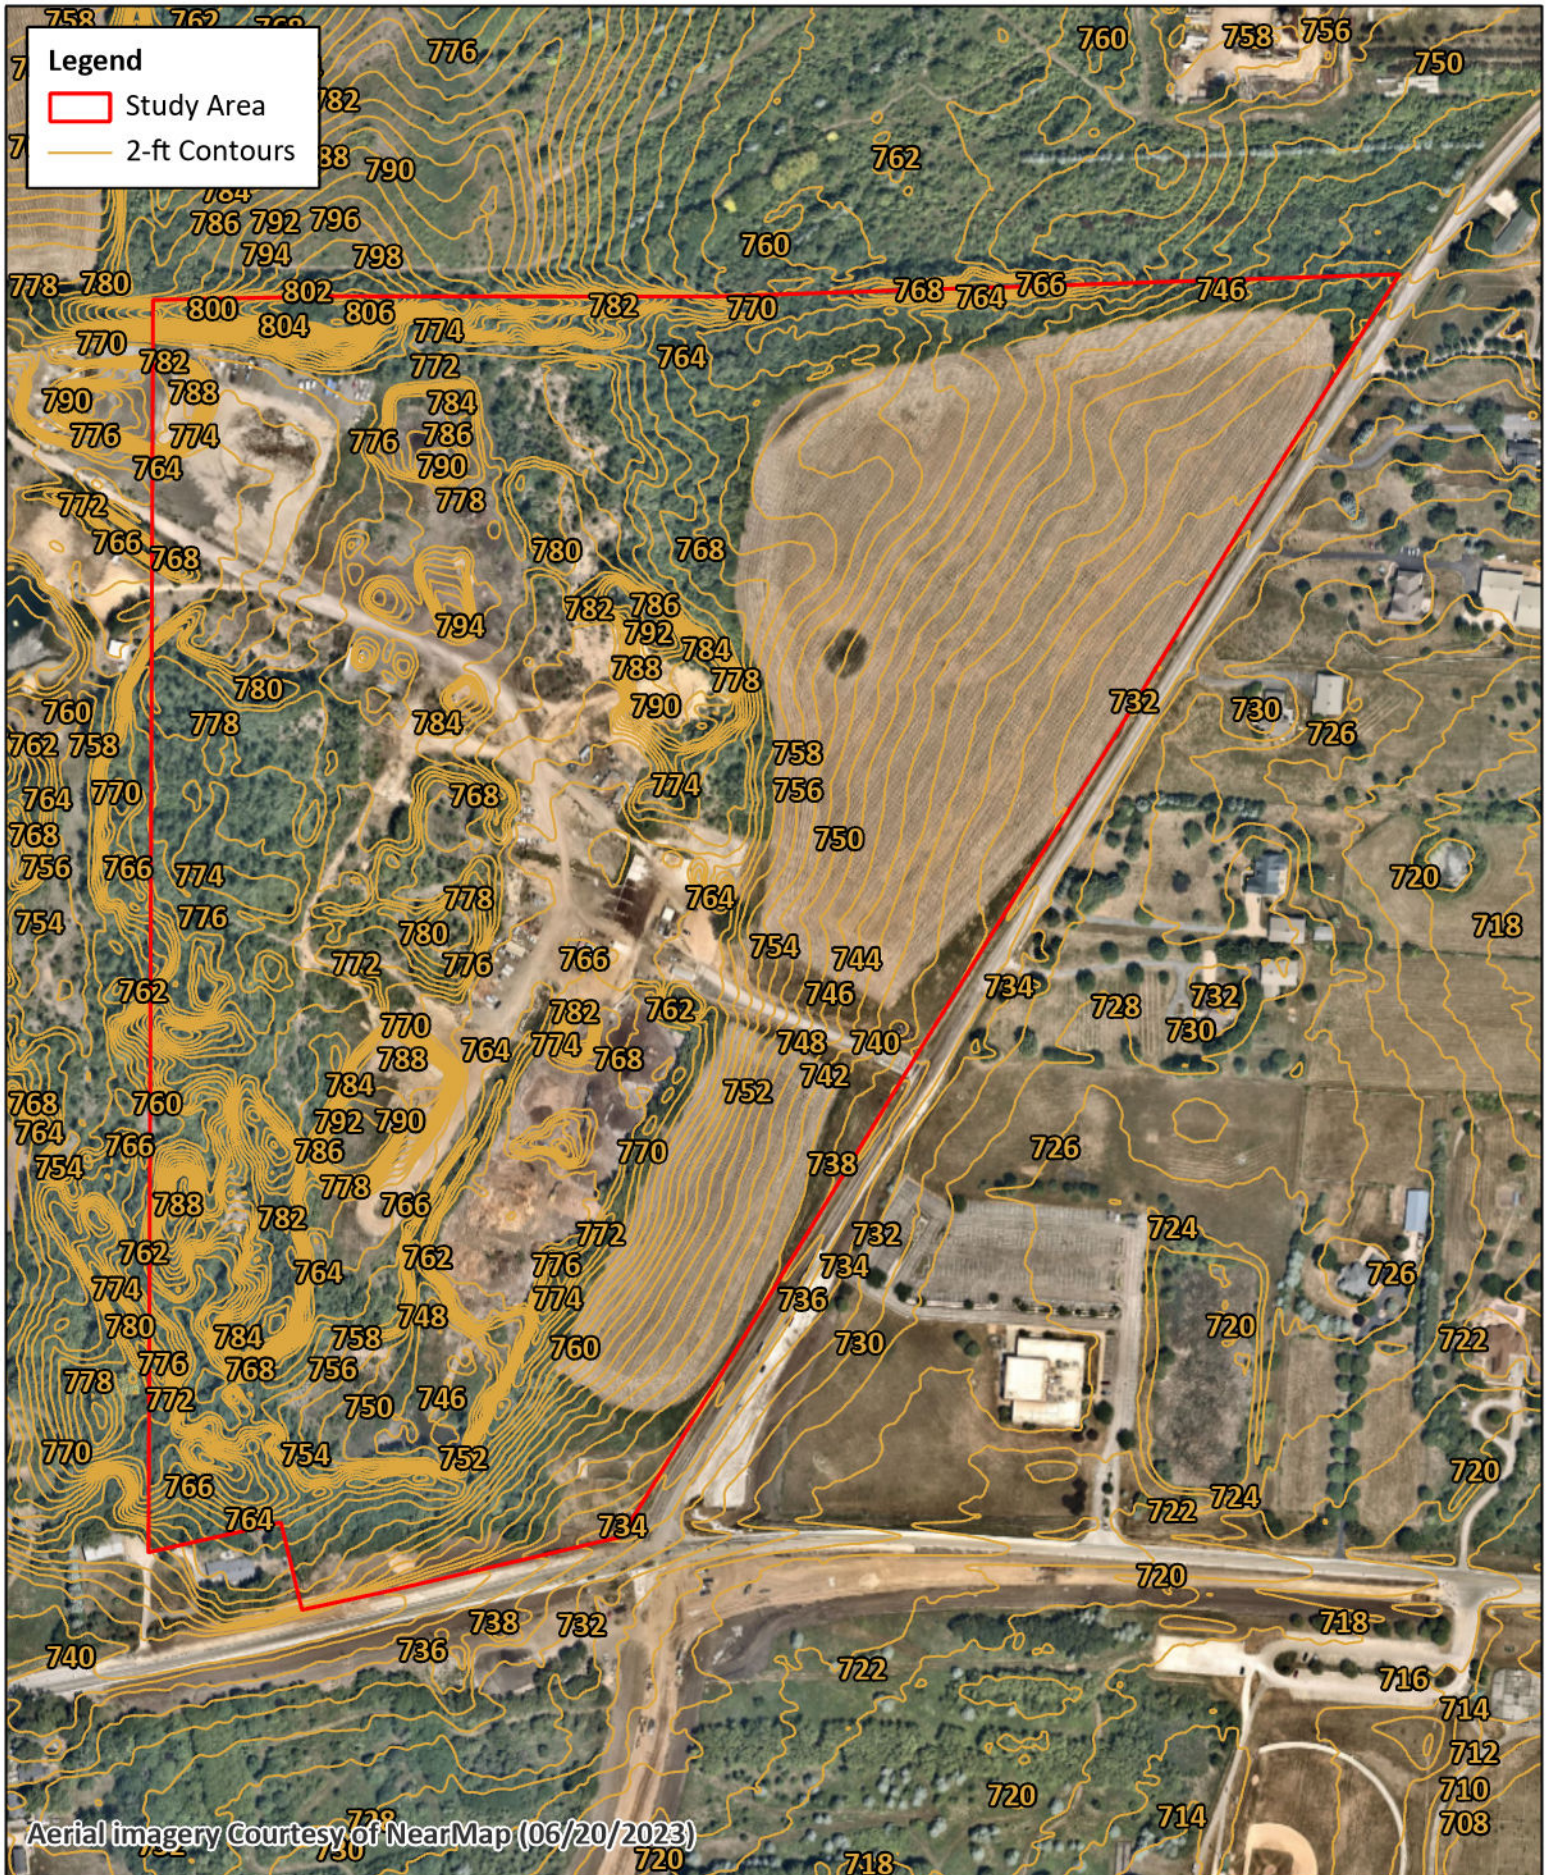
Based on a review of the U.S. Fish and Wildlife Service (USFWS) NWI,<sup>1</sup> portions of 4 wetland features are present within the study area. The NWI-mapped features are identified as excavated ponds (PUBGx). The NWI-mapped features are presented on Figure 4.

Based on a review of the USGS NHD,<sup>2</sup> portions of two unnamed flowline segments transect the study area. One unnamed waterbody is present within the study area. The NHD-mapped resources are presented on Figure 4.

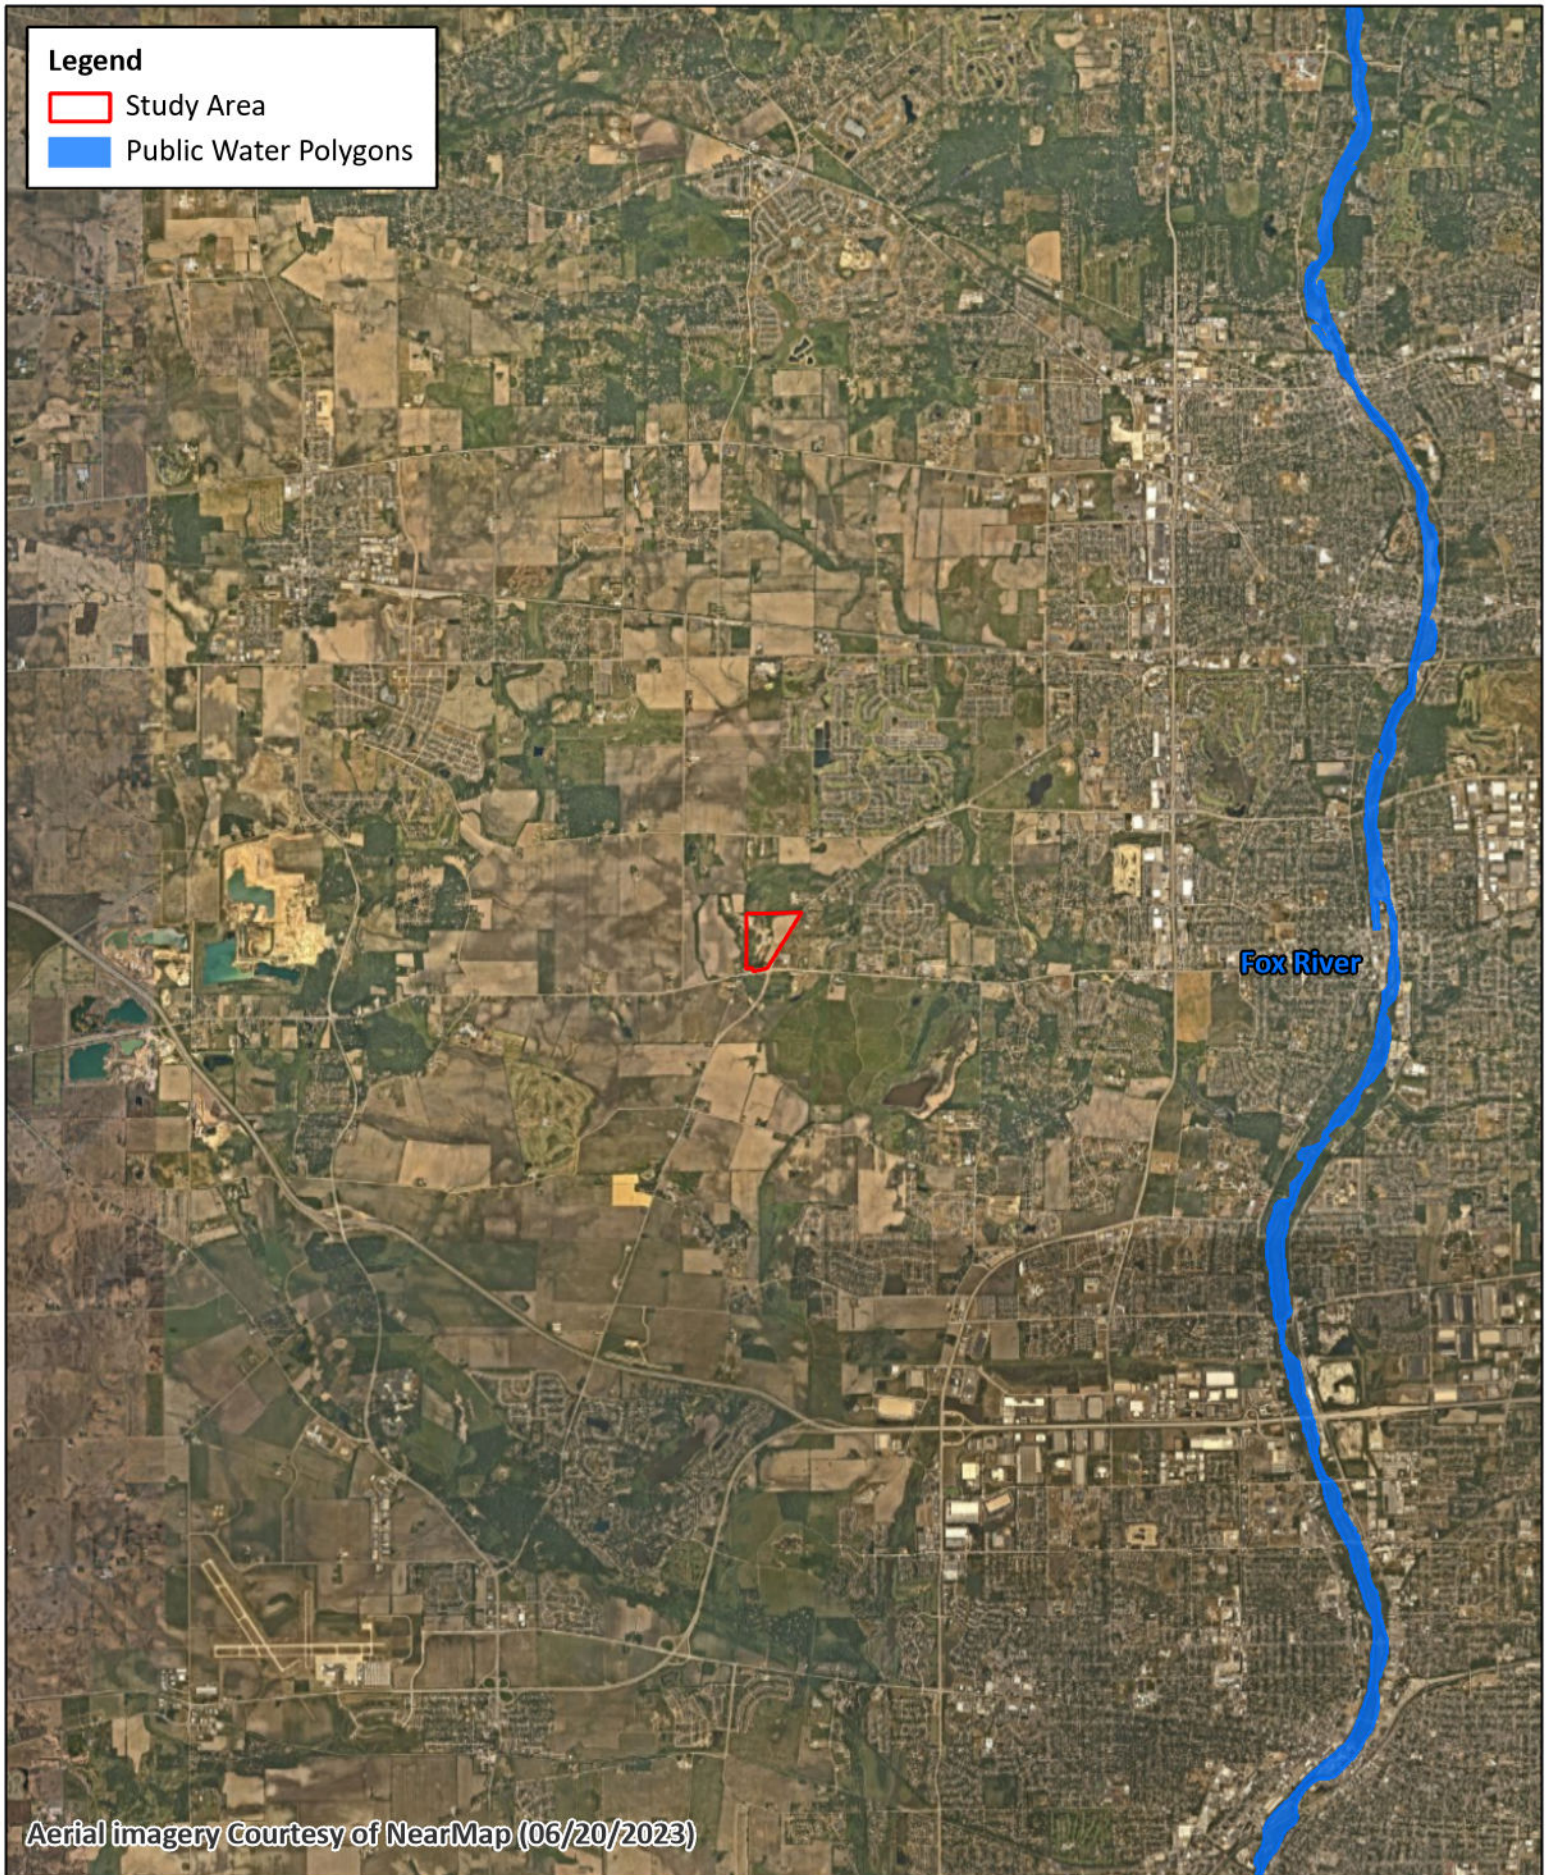
## Hydric Rating by Map Unit

A review of the Kane County soil survey via the United States Department of Agriculture (USDA) Natural Resources Conservation Service (NRCS) Soil Survey (WSS) database<sup>4</sup> identified 9 soil types within the study area. The entire study area is mapped with a predominantly non-hydric soils rating at or below 8 percent, or a non-hydric soils rating of 0 percent. Hydric soils rating data are presented on Figure 6.

Map unit symbol	Map unit name	Rating	Acres in AOI	Percent of AOI
59A	Lisbon silt loam, 0 to 2 percent slopes	8	1.0	1.2%
318C2	Lorenzo loam, 4 to 6 percent slopes, eroded	0	0.1	0.1%
325C2	Dresden silt loam, 4 to 6 percent slopes, eroded	4	4.5	5.5%
512B	Danabrook silt loam, 2 to 5 percent slopes	8	7.0	8.5%
512C2	Danabrook silt loam, 5 to 10 percent slopes, eroded	8	7.8	9.5%
662B	Barony silt loam, 2 to 5 percent slopes	0	2.5	3.0%
865	Pits, gravel	0	50.6	61.7%
969E2	Casco-Rodman complex, 12 to 20 percent slopes, eroded	0	8.4	10.2%
W	Water	0	0.3	0.3%
<b>Totals for Area of Interest</b>			<b>82.1</b>	<b>100.0%</b>

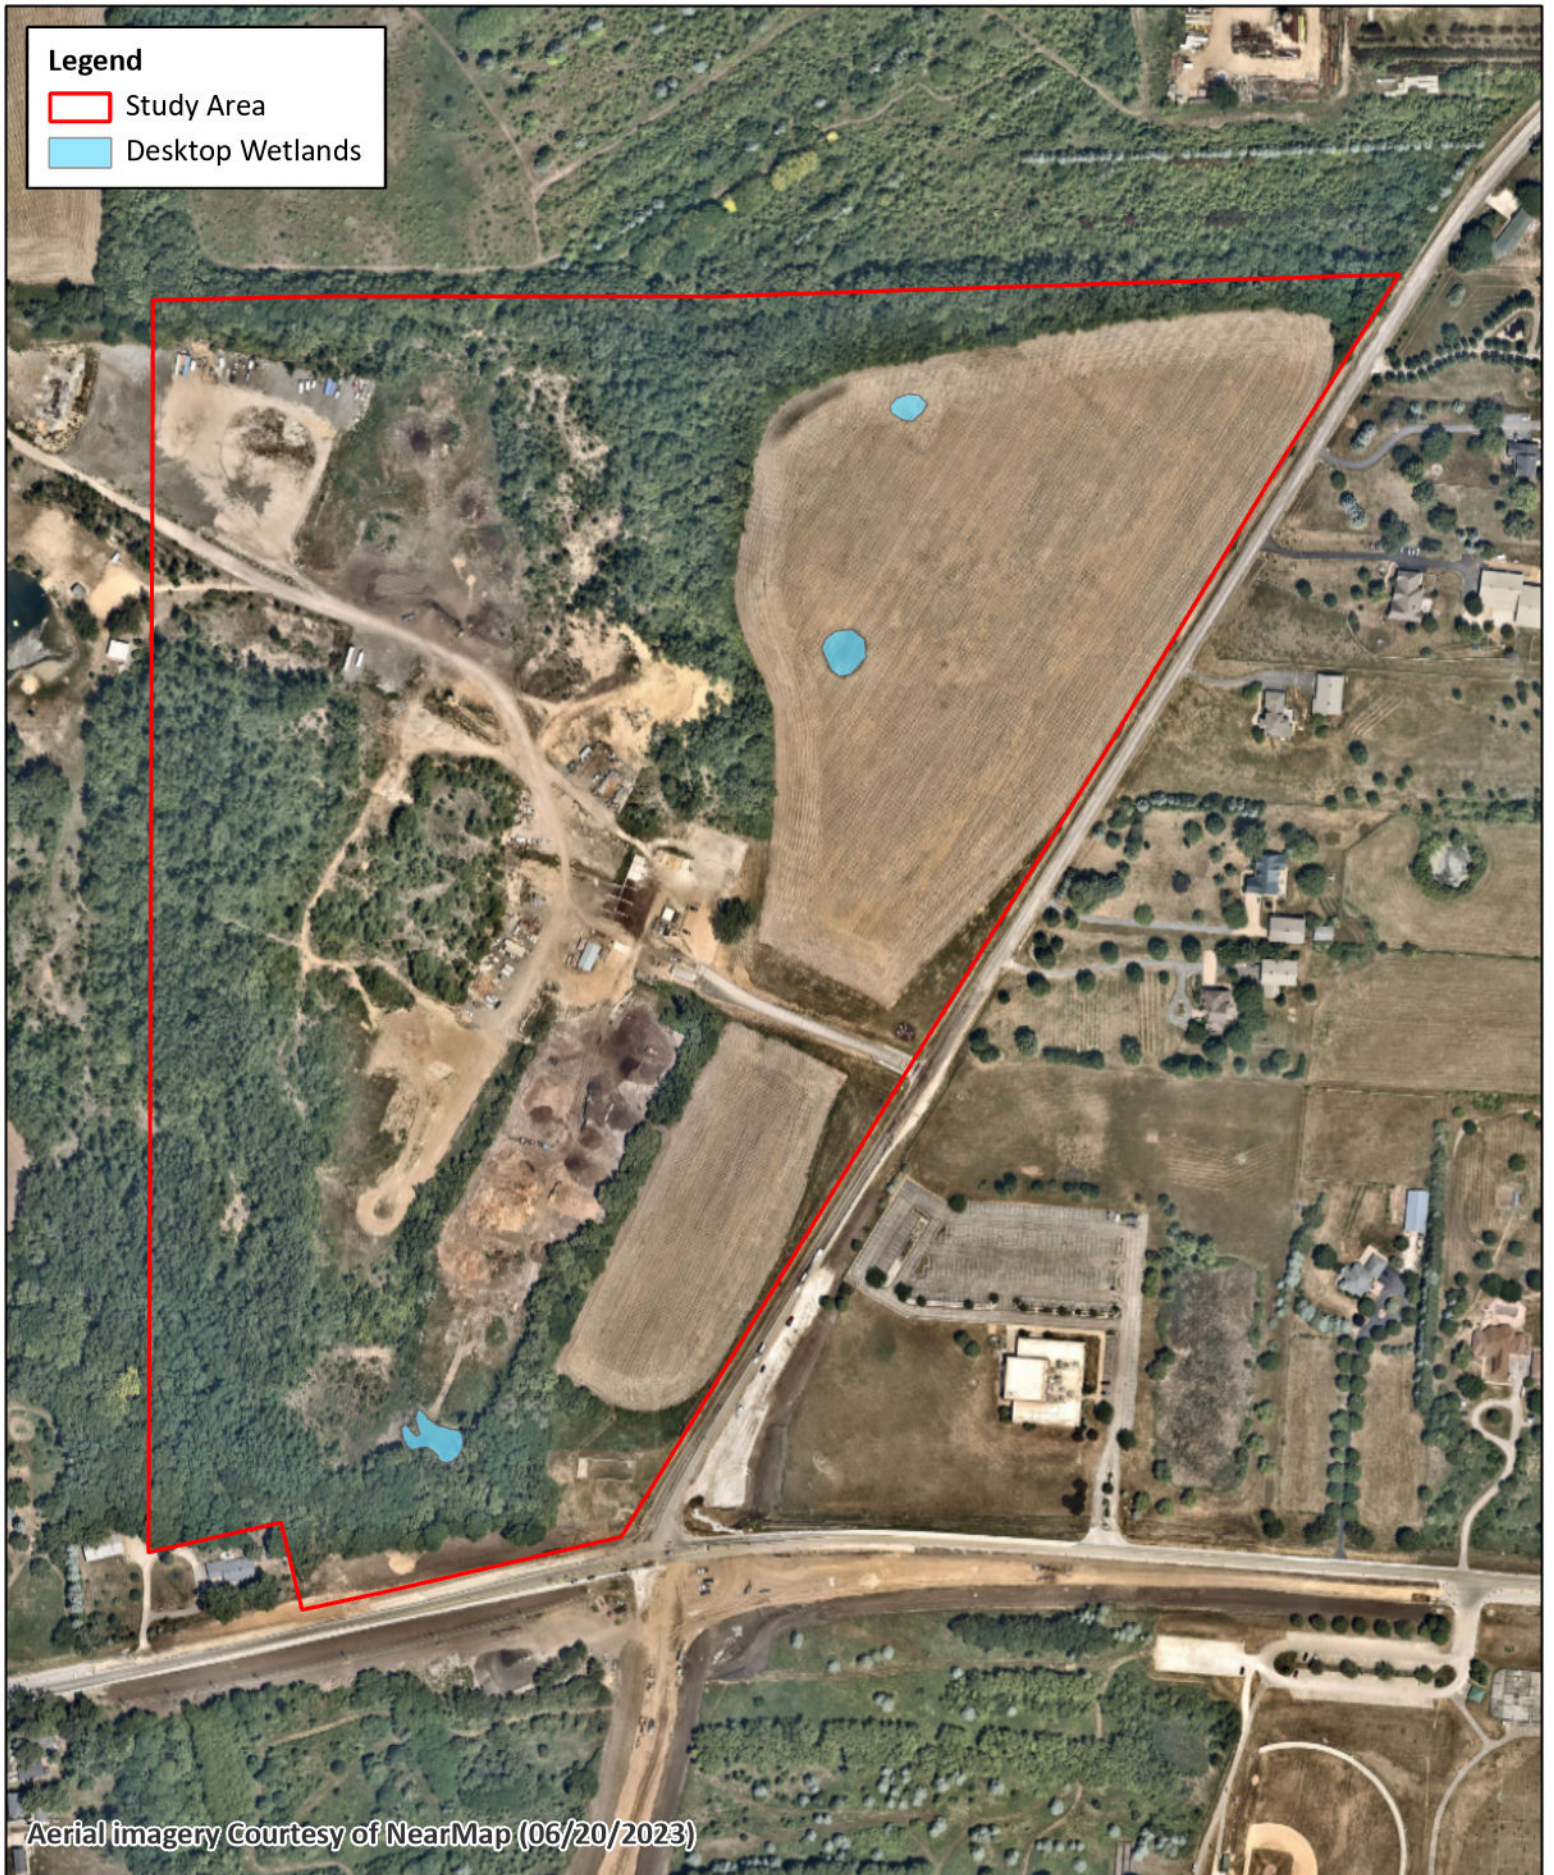
**Figure 9. Level 1 Delineated Resources**  
Blackberry Township, Kane County  
Turning Point Energy

Based on the Level 1 Wetland Delineation, Kimley-Horn identified two potential agricultural wetlands in the northern portion of the agricultural area and one pond in the southern central portion of the forested study area (see Figure 9). A level 2 (field) wetland delineation is recommended if project infrastructure is located near the two potential agricultural wetlands and one pond in the study area. If the current (as of the date of this report) project extents remain as-is, a field delineation would be needed. If project infrastructure will avoid the potential wetland features, a field delineation would not be needed. The site plan is included as Attachment B.
