Water Resources Delineation Report

37.7 Acres, KaneSolar02, Lincoln Highway, Kane County, Illinois

December 12, 2022

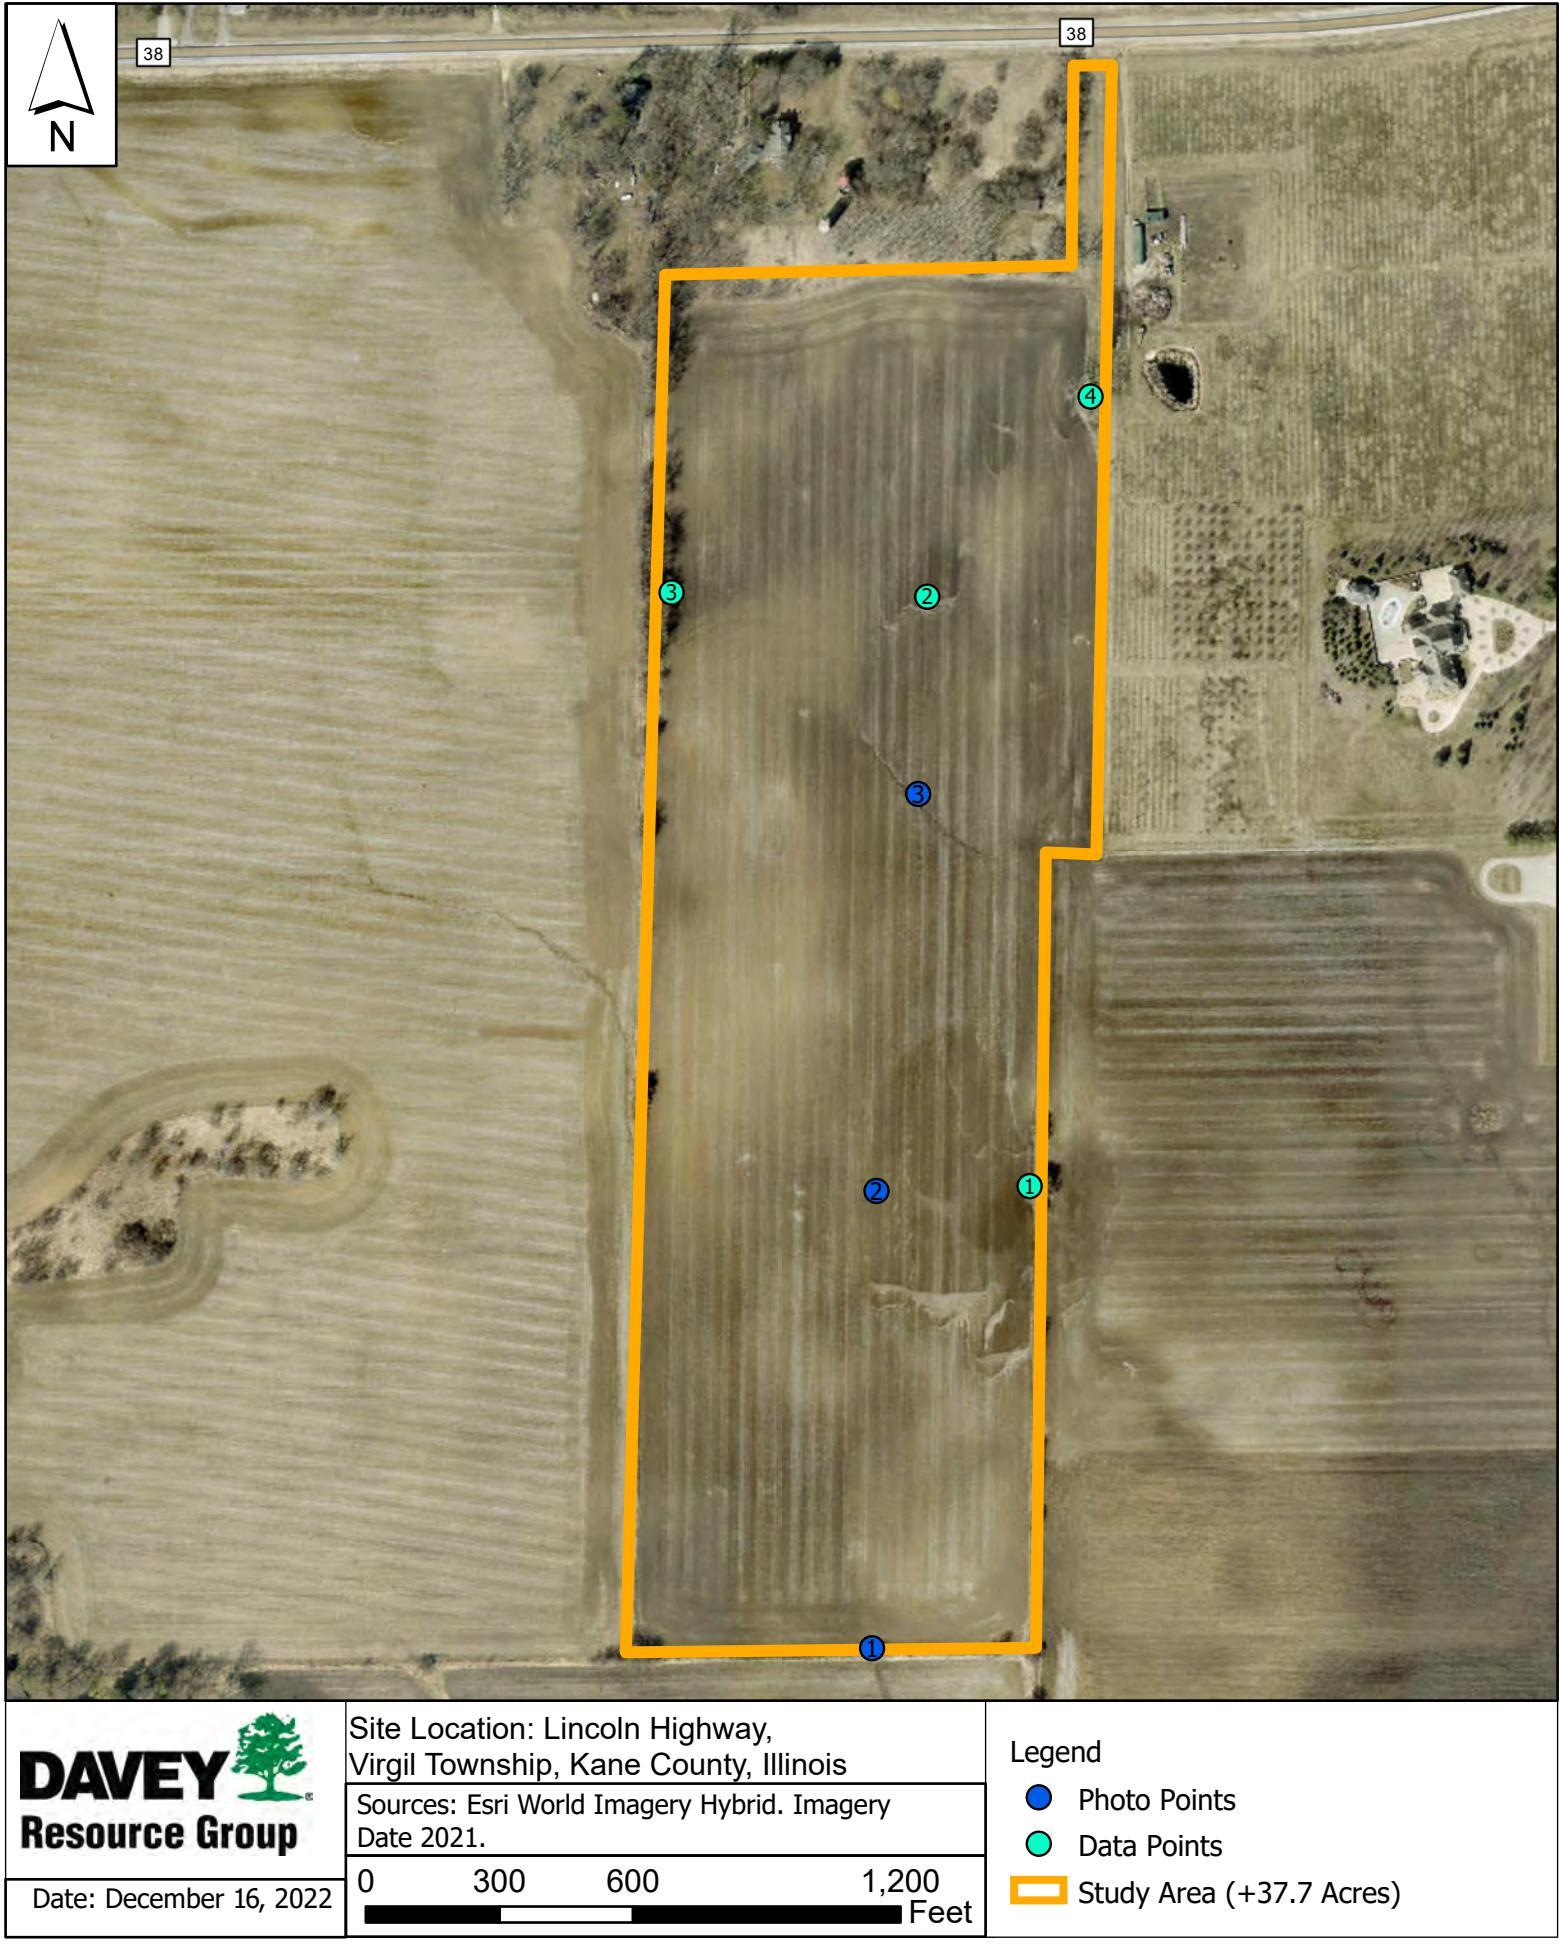
Appendix A: Mapped Water Resources

A map of the location and size of the property is shown in Appendix A. No water resources were identified within the study area.

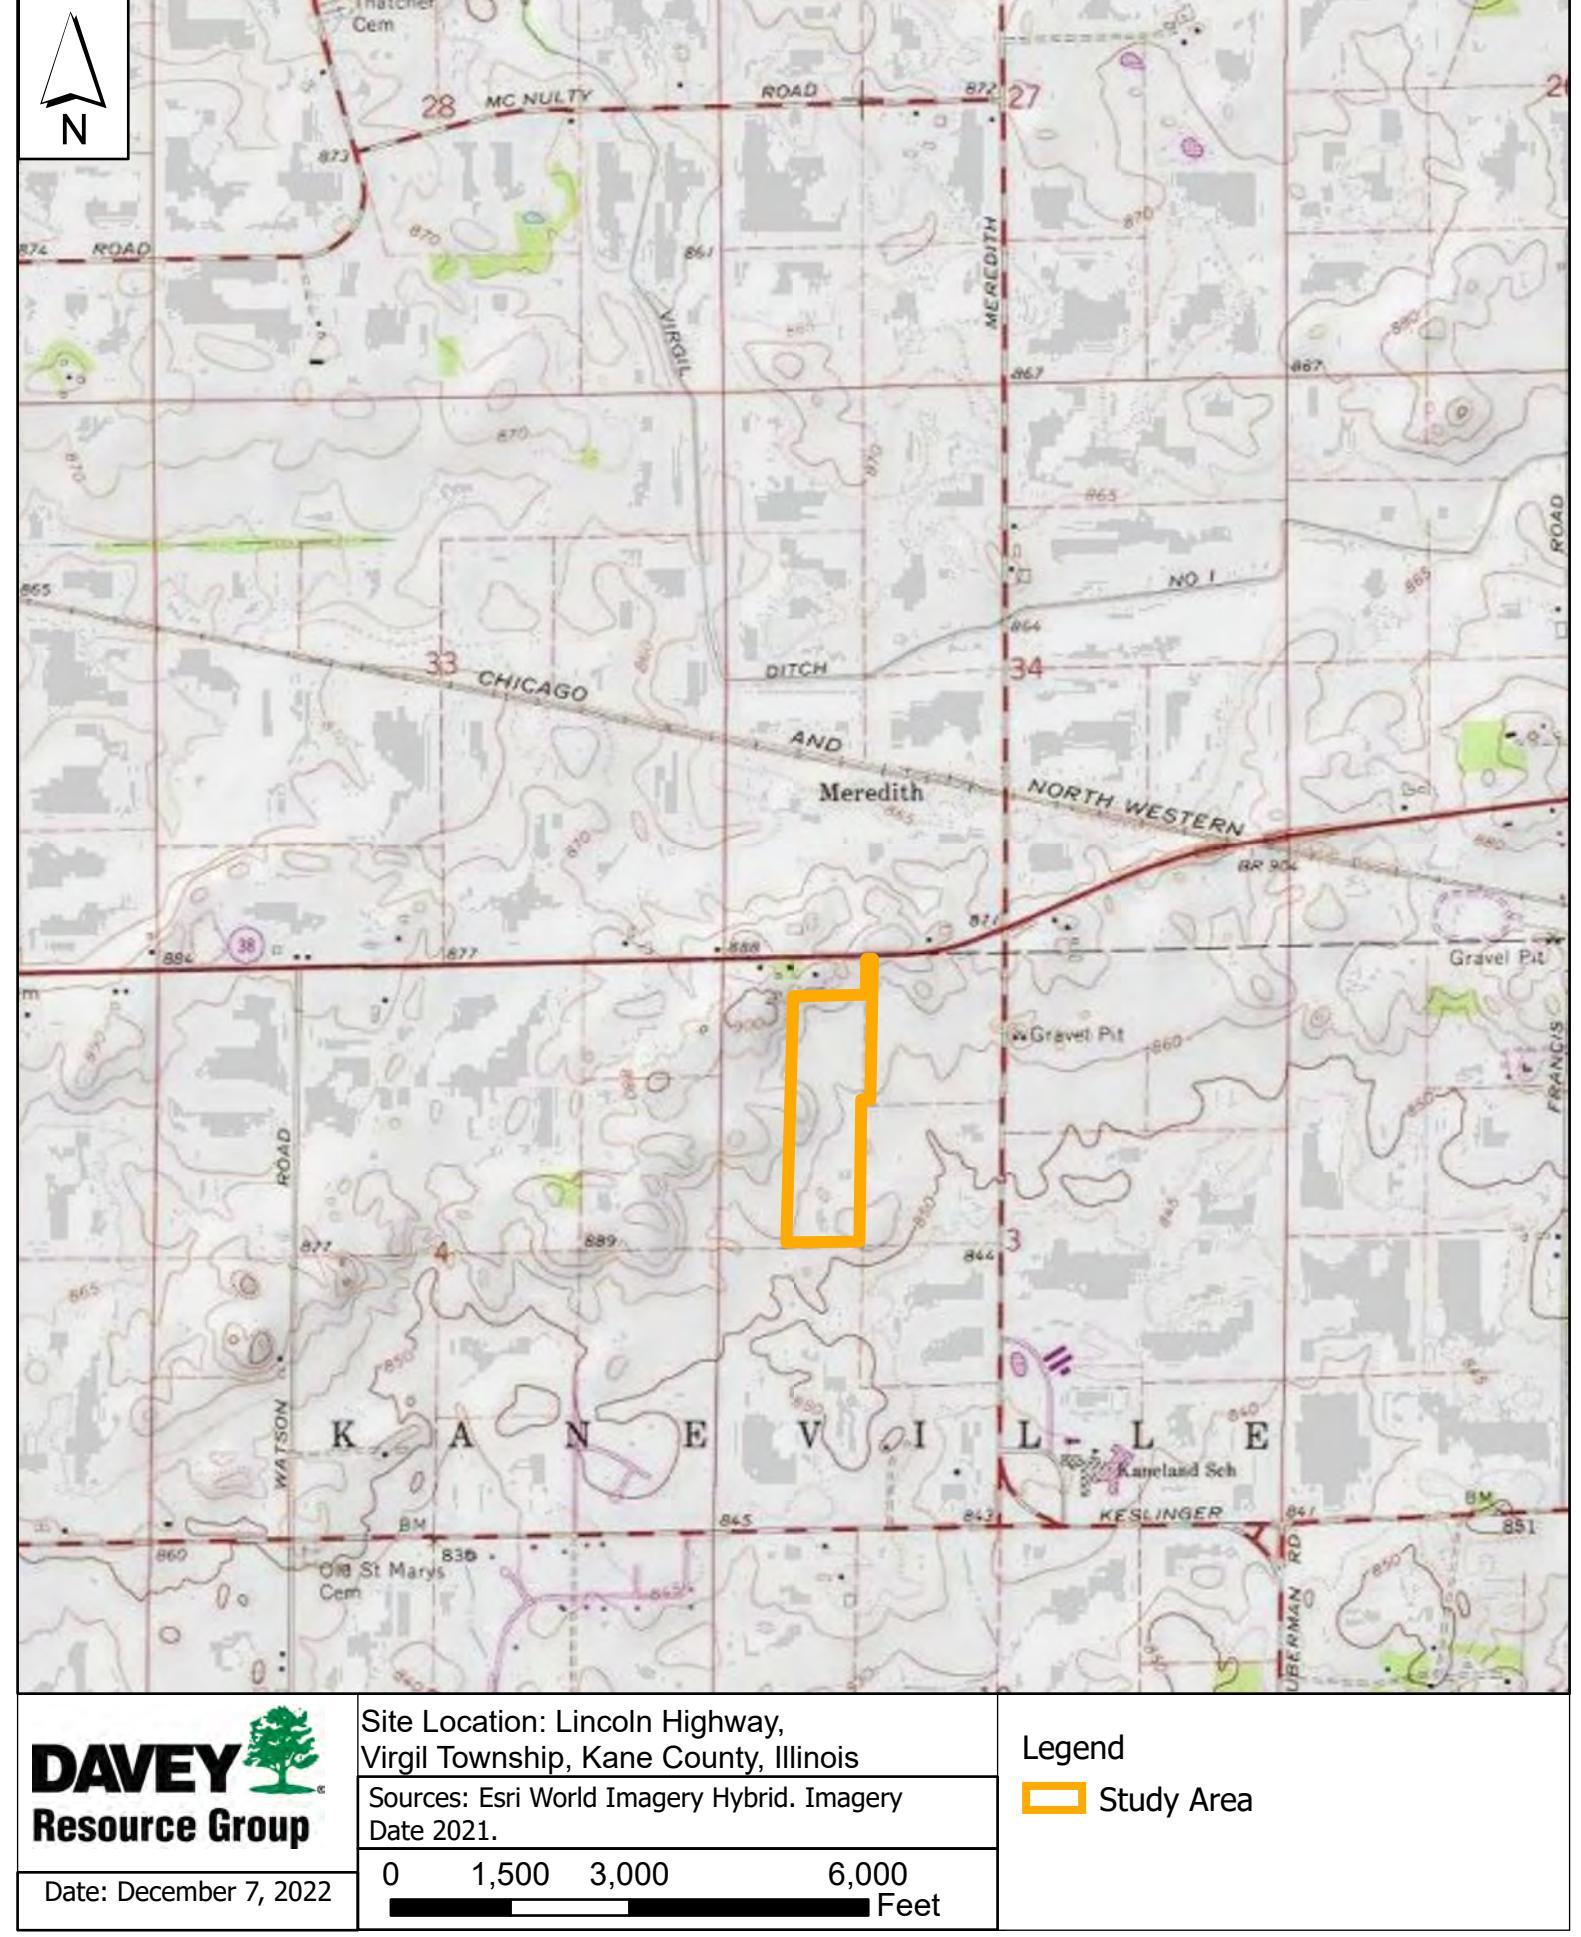
Appendix E: Location of Study Area on USGS 7.5 Minute Topographic Map

The study area is shown on the Maple Park Quadrangle of the United States Geological Survey (USGS) map (Appendix E). The study area is between 880 and 855 feet above sea level.

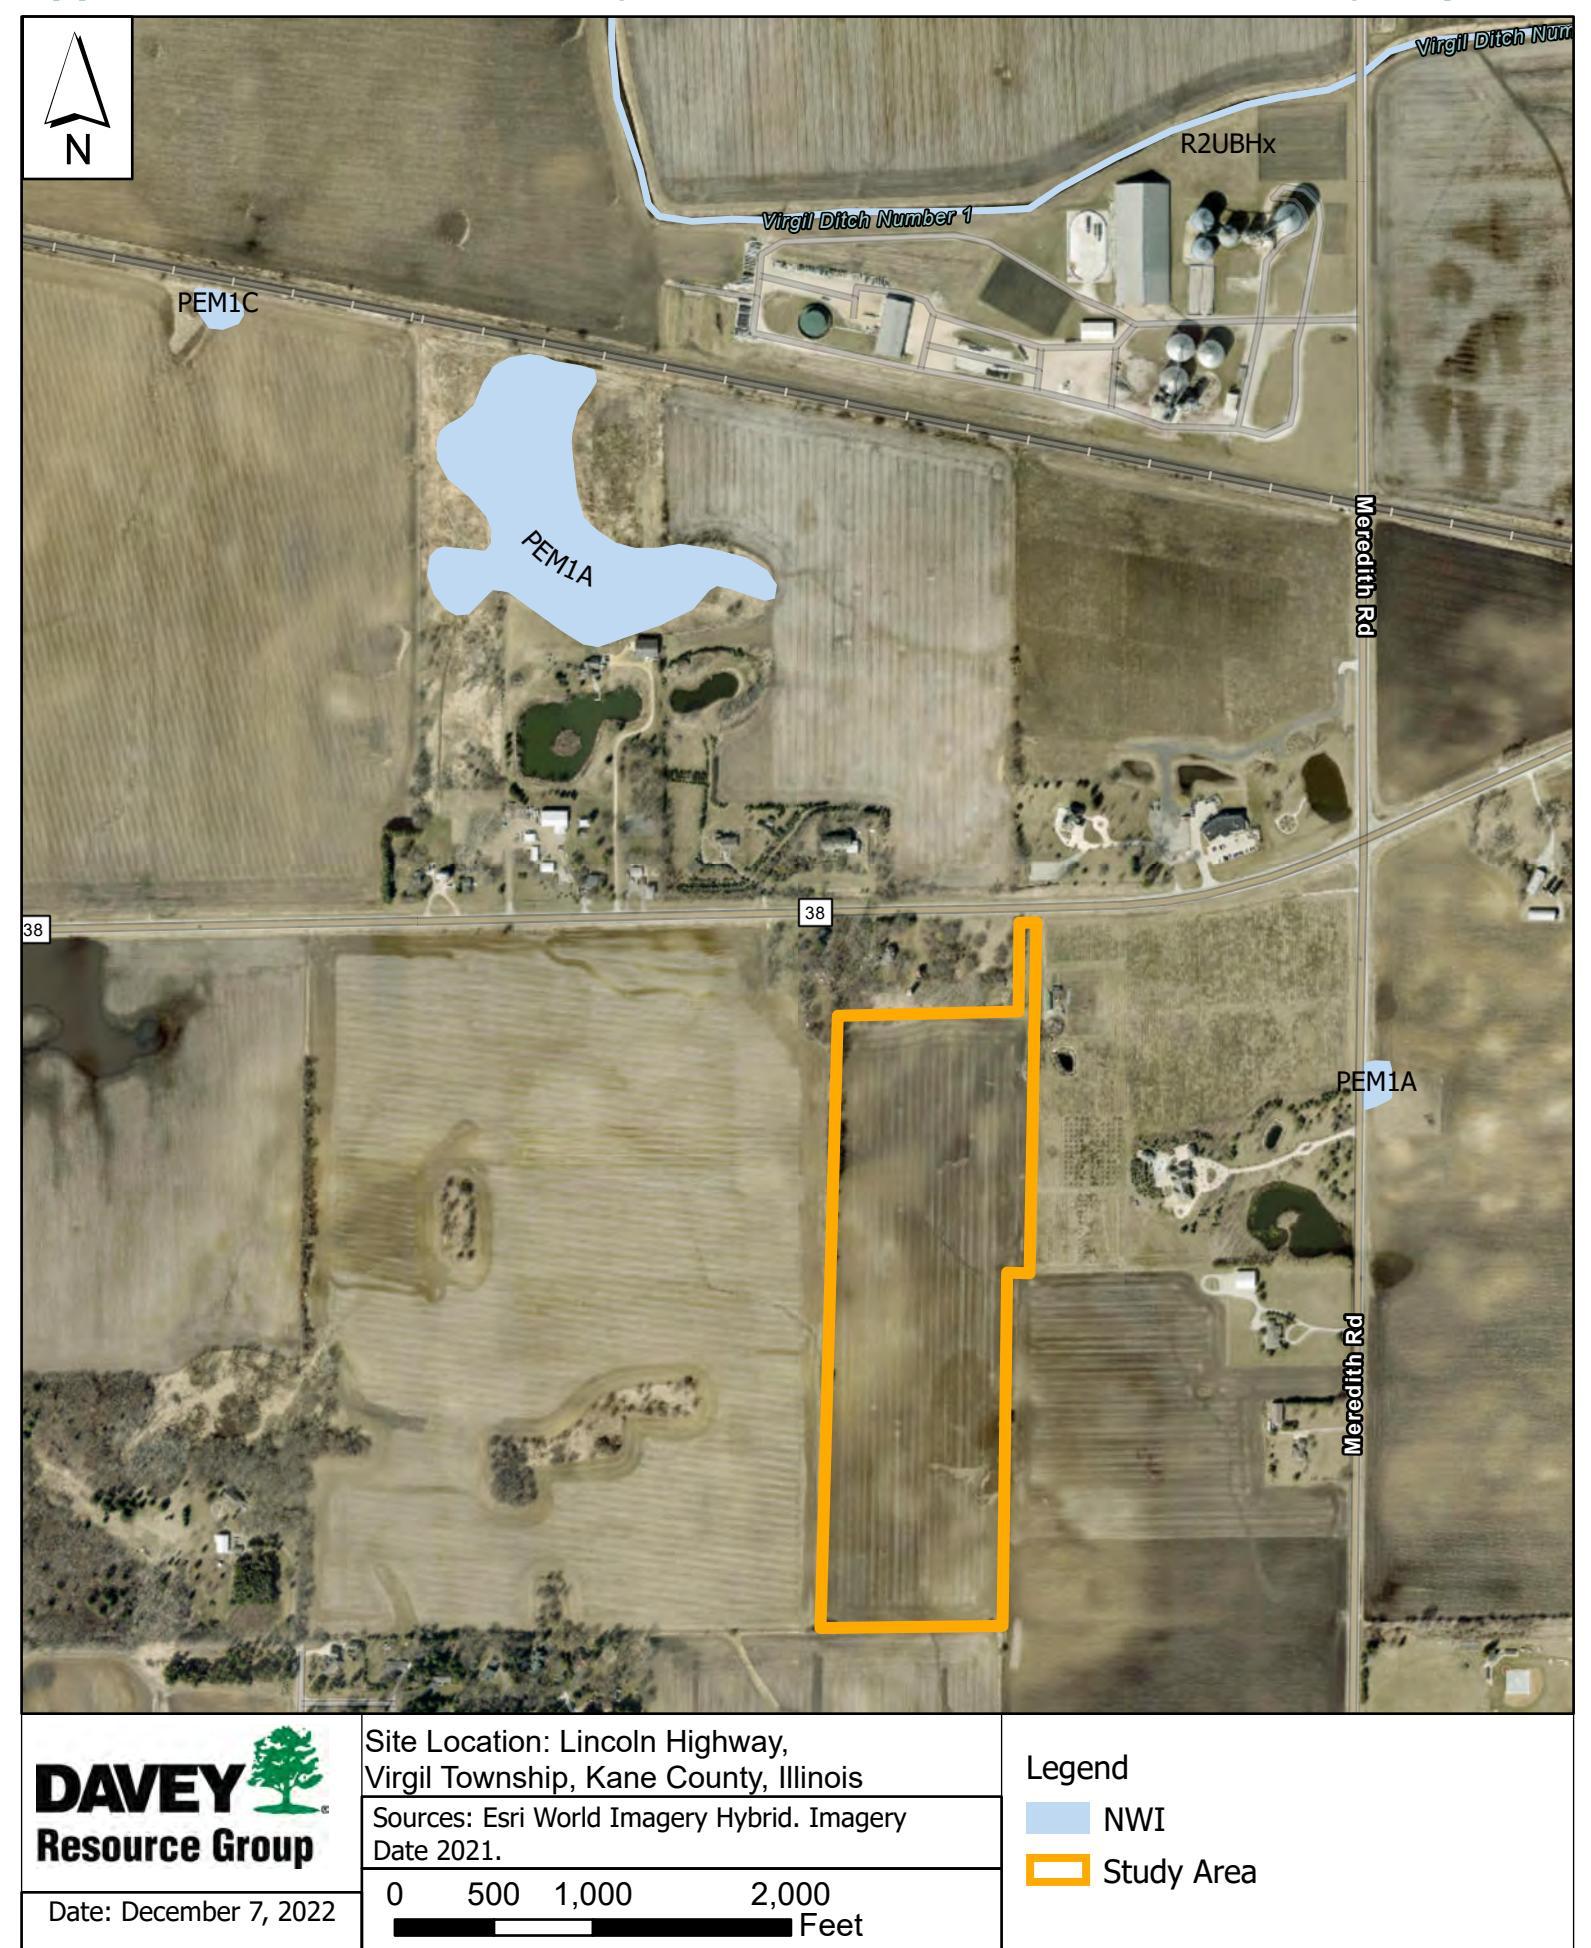
Appendix F: Location of Study Area on National Wetland Inventory Map

A National Wetlands Inventory (NWI) map showing nearby NWI wetlands is located in Appendix F.

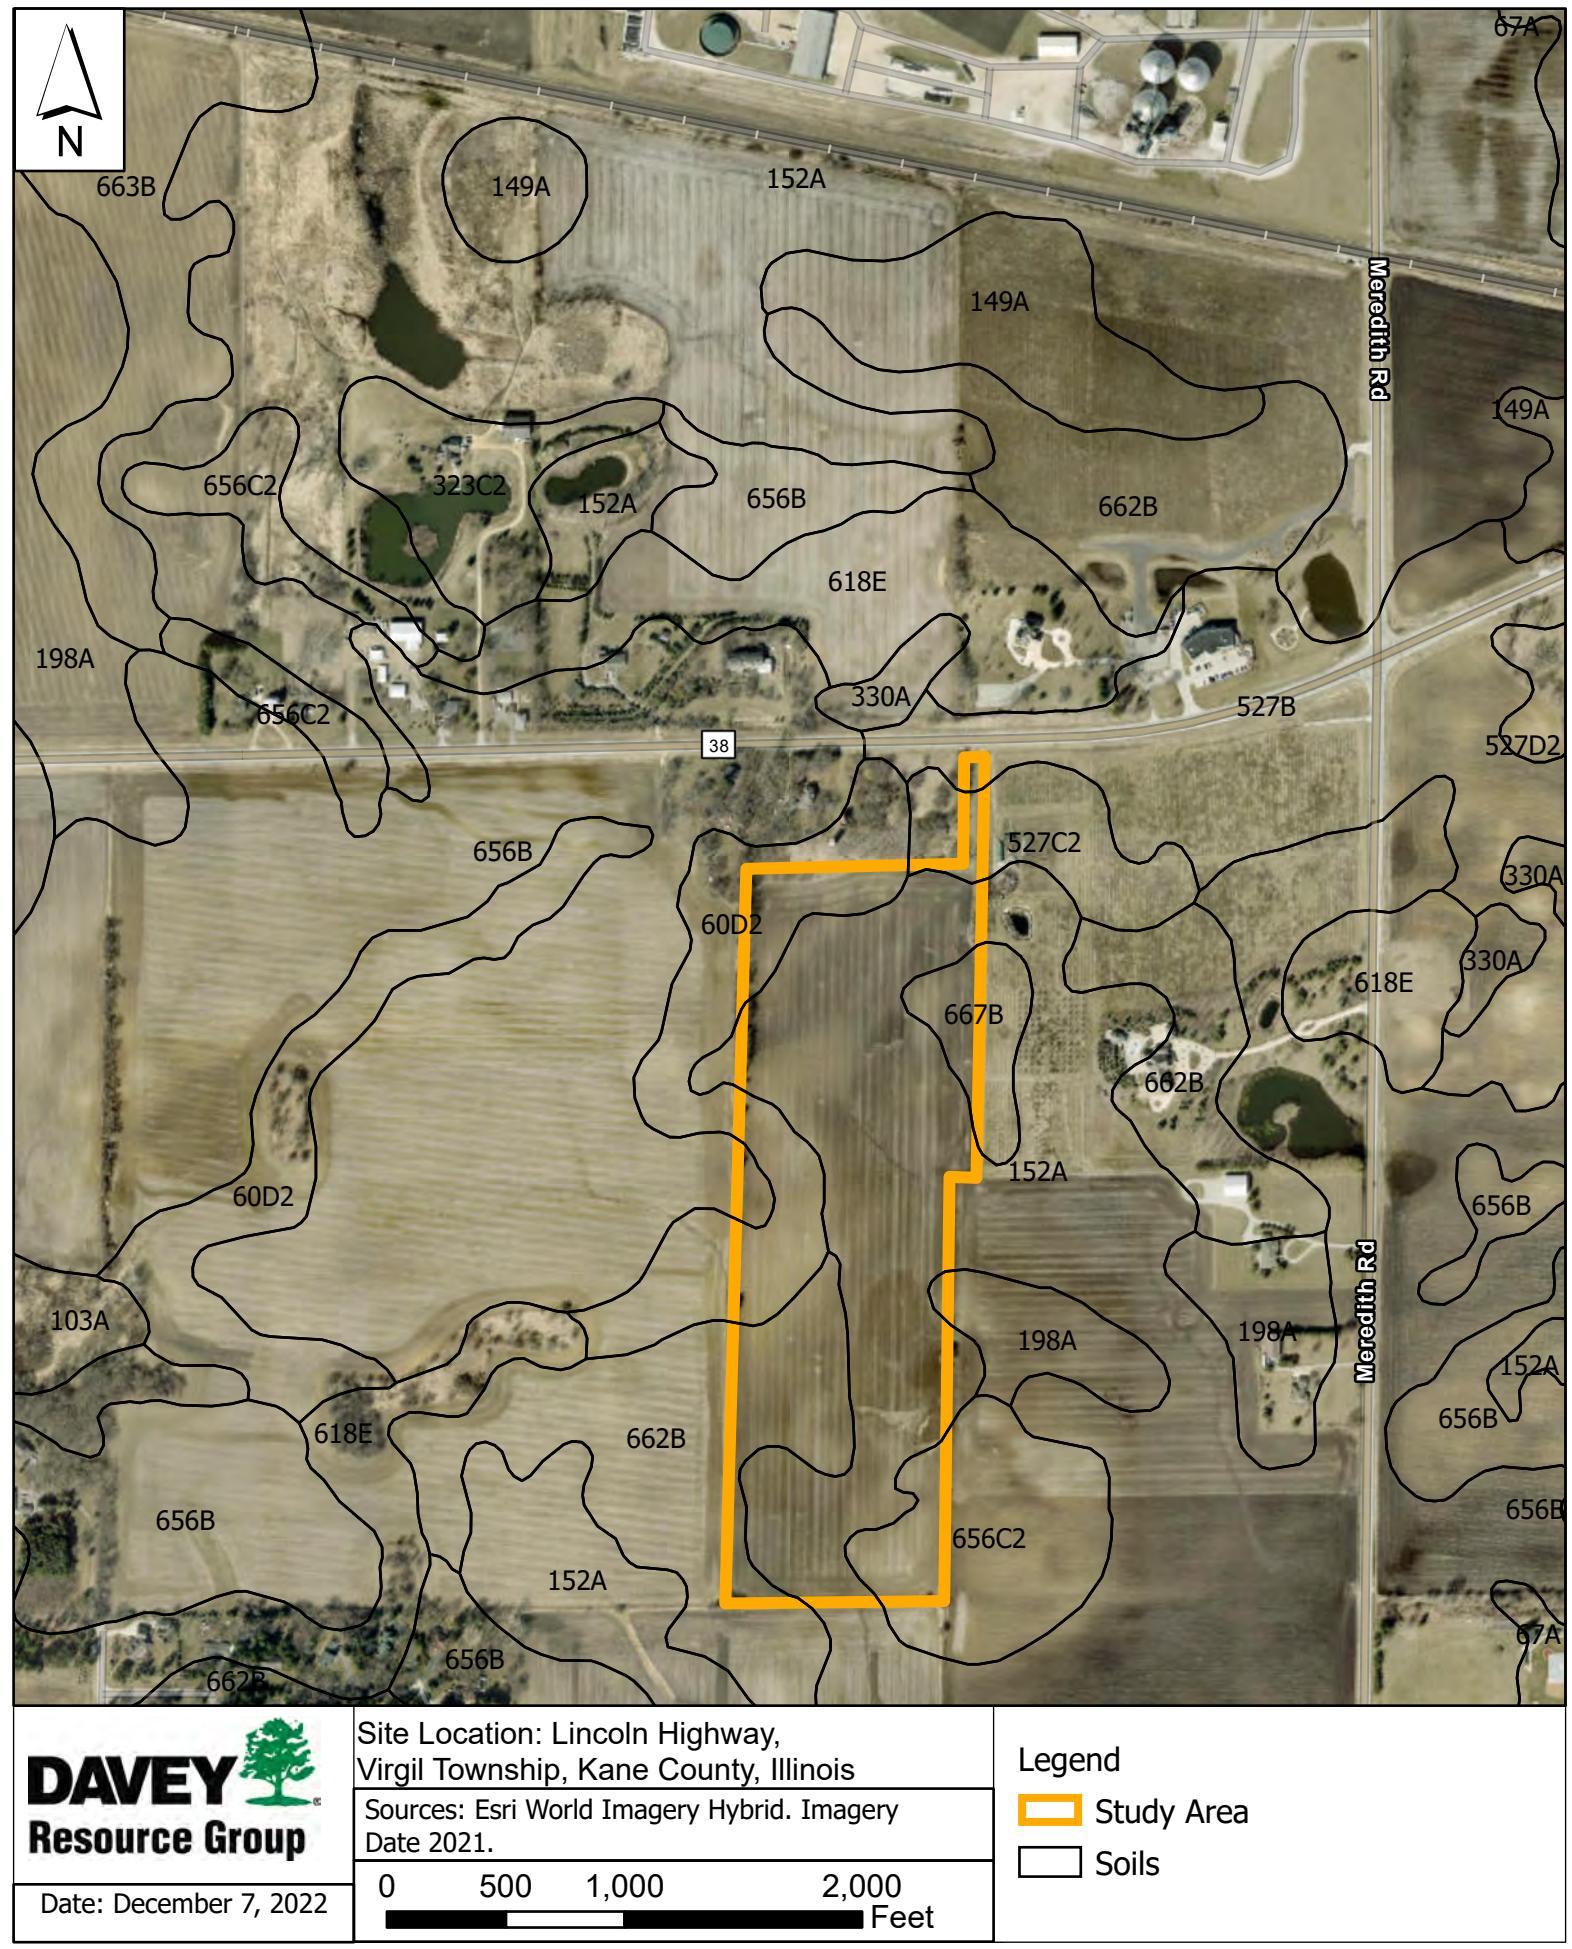
Appendix G: Location of Study Area on Soil Survey Map

A map from the United States Department of Agriculture Natural Resources Conservation Service Web Soil Survey showing the soil types located on and adjacent to the site is found in Appendix G. The *Hydric Soils of the United States* (1991) was reviewed to determine potential hydric soils identified within the study area. Table 1 provides a list of soil types mapped for the site.

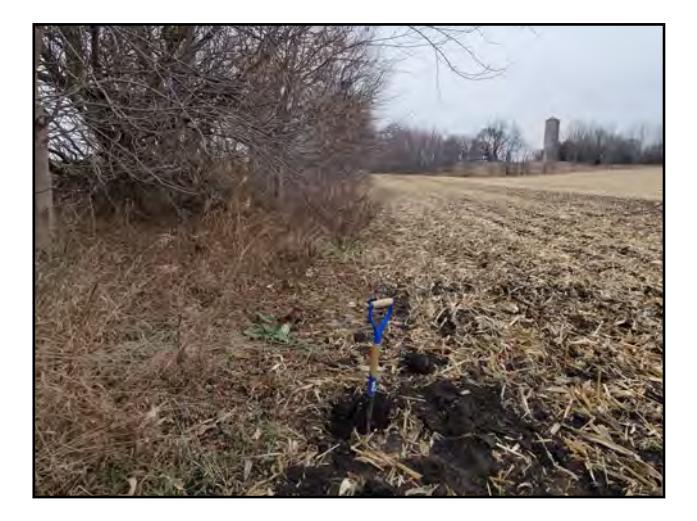
DP03, View looking north

The site contains an agricultural field with hills and valleys. No wetlands were identified during the 2022 site visit. Only one of the 4 data points (DP3) taken met the hydric vegetation criteria. Photograph locations are shown in Appendix A. Photographs showing water resources identified on the site are included in Appendix I. Wetland assessment data forms are included in Appendix K.
